## In-situ compositional analysis of economiser tubes within the sub-boiler annulus of an AGR pressure vessel (2001)

### Overview of application

In early 2001, a FO-LIBS instrument was used to remotely determine the chromium content of mild-steel economiser tubing within the Sub-Boiler Annulus (SBA) of reactor 4 at Hunterston B station. The measurements were required as part of an inspection programme undertaken to identify tubes that had suffered damage through the effects of a process known as erosion-corrosion. Erosion-corrosion is a significant problem in the nuclear industry since it can lead to the thinning of tube walls at rates of up to several mm/yr. Erosion-corrosion is a mechanical process affecting tubes whereby oxide crystals are removed from the surface of the tube wall either by high shear-stress or particles introduced via the flow. Erosion-corrosion has been found to be particularly associated with mild-steel tubing at elevated temperatures of 90-300°C. The rate of erosion-corrosion depends on various factors including temperature, flow-rate, water chemistry and the composition of the tube material. Tubes manufactured from mild-steel containing less than approxim

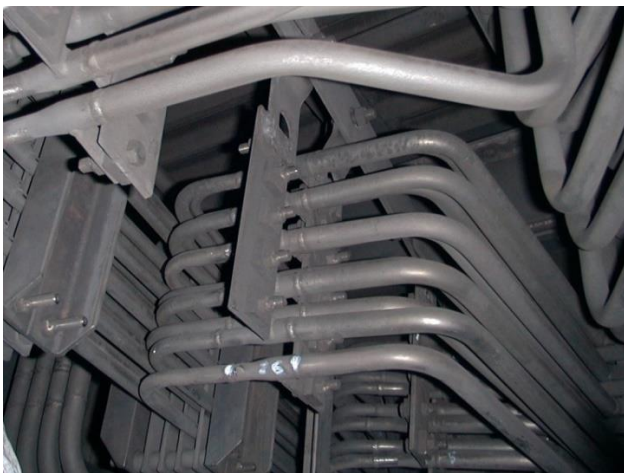
Economiser tubes located in the SBA (left). Protective clothing and equipment required for man-access to SBA (right)

| <b>Location of material:</b> | Economiser tubes located directly above temporary scaffold structure |
